An assessment of the sustainability of use of selected dambos in the Mpika District, Zambia and Kasungu District, Malawi

18 September 2019

Donovan Kotze¹ and Adrian Wood²

Submitted to Self Help Africa, Dublin, Ireland

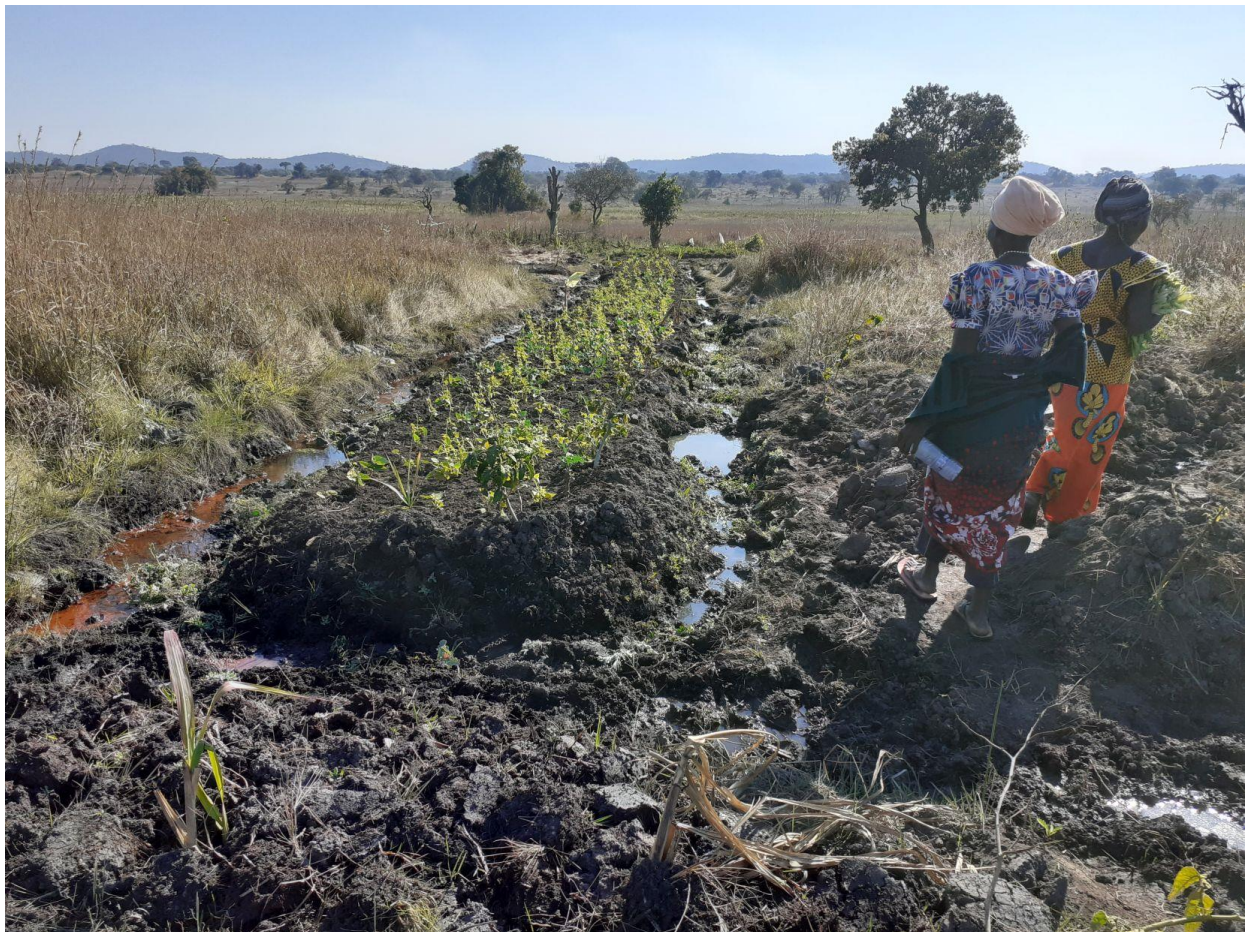
Plate 4.1: A cultivated area of Mwansabamba dambo with high ridges orientated directly down the slope

In both 2008 and 2019, the cultivation in Chikakala and Mwansabamba dambos took place predominantly using the ridges and furrows described by Sampa (2008), which are designed to control waterlogging (which limits the growth of all of the cultivated crops) while at the same time providing adequate supply of water for crops (Sampa, 2008). This is achieved by locating the plots within areas in the dambo which remain fed by seepage waters through most of the dry season, but avoiding the excessively wet central areas of the dambo and the drier portions of the dambo. The ridging system concentrates naturally-diffuse flows within the furrows, which are mainly orientated diagonally down the slope rather than along the contour. In addition, on the ridges the land surface is raised relative to the water table by about 10 to 20 cm. Overall therefore, the level of wetness of the ridged areas is lowered, but this is not a severe alteration given the fairly shallow nature of the ridges and furrows. In 2008, the Chikakala and Mwansabamba the ridges appear to have been similar in terms of height and orientation. In 2019, while the same ridges were used, some slight shifts had occurred, with implications in terms of hydrological impact. In Chikakala, in response to an above-average preceding wet season there had been a slight shift in location of cultivation more towards the drier margins away from the wetter lower slopes, resulting in a slightly lowered hydrology impact intensity score seen in Appendix E. In Mwansabamba this shift has been to a lesser extent than in Chikakala, with farmers tending more to adjust to the wetter conditions by increasing the height of the ridges, orientating the furrows with the direction of water flow (Plate 4.1) and, in some cases, constructing additional drainage ditches to speed up the removal of excess water². This has increased the impact intensity on the hydrology, as reflected in the scores in Appendix E, Table E1.

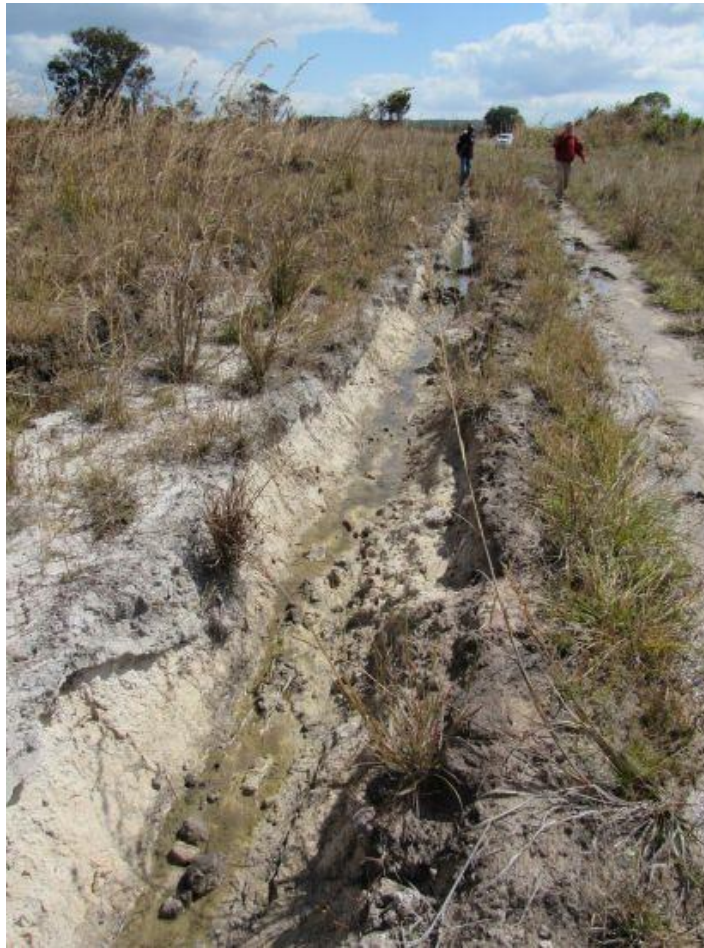
Plate 4.2: A Minor erosion feature precipitated by an uncompleted road in Mwansabamba dambo

lateral inflows. However, in Mwansabamba, initial preparation carried out in 2016 for a major uncompleted road through the wetland has resulted in the localized concentration of lateral flows into the wetland, which in turn has caused rill and minor gully erosion, further concentrating flow down this feature (Plate 4.2).

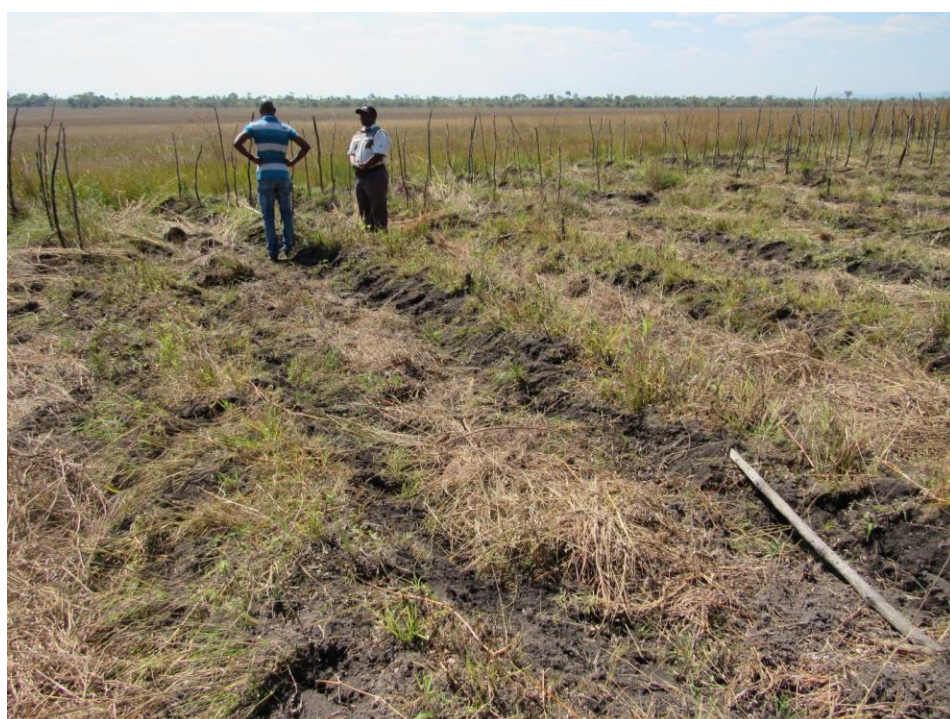
Plate 4.3: A portion of a cultivated plot in the Chikakala dambo, with “weed” and crop residues from previous crop gathered in the furrows in preparation for the ridges to be “split” and hoed on-top of the residues as the new ridges are created.

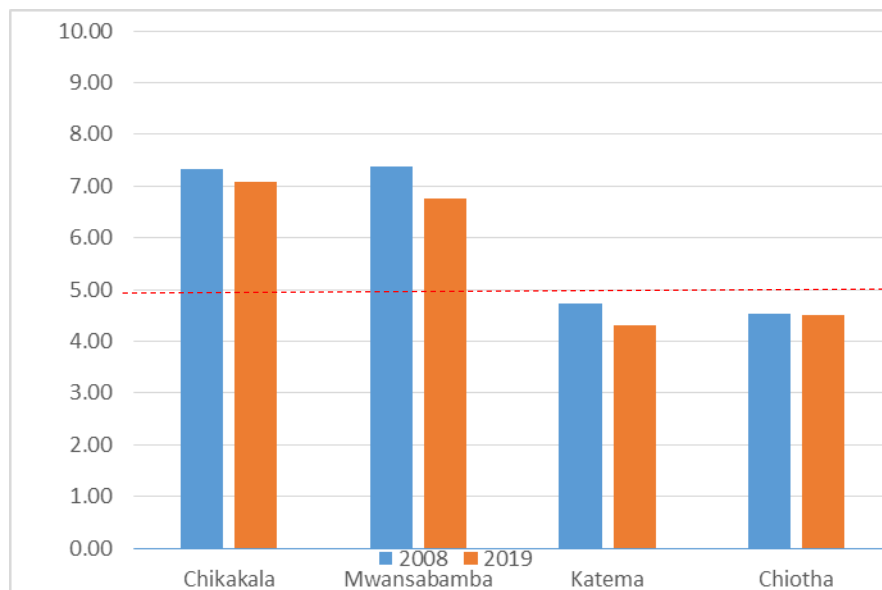
Figure 4.5: The vegetation component for the health of four dambos assessed in 2008 and 2019, with health represented on a scale of 0 (critical) to 10 (pristine) and the Threshold of Potential Concern for Supporting Livelihoods (explained in Section 4.1.7) shown as a dashed red line.

In both the 2008 and the 2019 assessments, vegetation was consistently the most impacted of the five components of ecological health across all of the dambos (i.e. comparing Figure 4.5 with Figure 4.1 to 4.4). Comparing the vegetation component score for each dambo in 2008 and 2019 (Figure 4.5) it can be seen that there was a general decline in scores for all dambos, but in Chiotha it was extremely slight, more pronounced in Mwansabamba and intermediate in Chikakala and Katema. From Appendix E, Table E5 it can be seen that the changes seen in Figure 4.5 are primarily as a result of shifts in the extent of different land-cover types (notably a decline in natural vegetation and an increase in the areas of cleared and fallowed land) but the intensity scores within the respective land-uses largely remained unchanged. In addition, as noted by Kotze (2011) the vegetation in Chiotha dambo appears to recover its natural composition far more readily than Katema, and probably also the other two dambos. This may be owing to the inherently higher soil nutrient levels of the Chiotha dambo, which is naturally dominated by a few competitive species such as *Echinochloa pyramidalis* compared with the nutrient-poor and naturally more species-rich situation in the other three dambos.

Both Katema and Chiota have fallen below the generic threshold of concern for vegetation given in Section 4.1.7, owing primarily to a fairly limited extent of remaining natural vegetation. However, there seems to be a greater basis for concern in the Katema dambo given the higher rate of decline in extent of natural area compared with Chiota, as elaborated on further in Box 1.

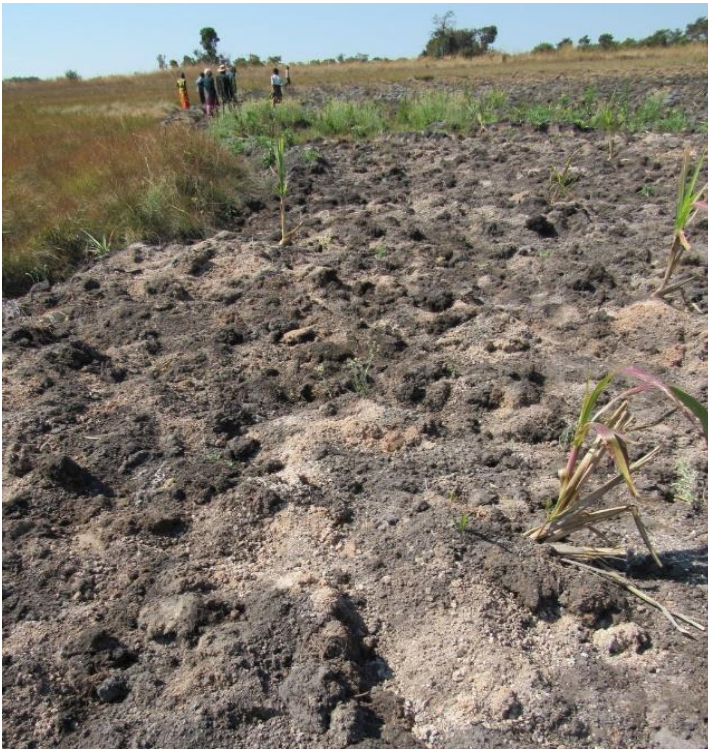
Plate 6.1: A cultivated seepage area in the Mwansabamba dambo with organic-rich soils which have burnt, increasing their vulnerability to erosion and leaching of nutrients.
